U.S.S. MONITOR

A FINAL REPORT
ON 1979 SITE TESTING IN THE MONITOR NATIONAL MARINE SANCTUARY

BY GORDON P. WATTS, JR.
NORTH CAROLINA DEPARTMENT OF CULTURAL RESOURCES

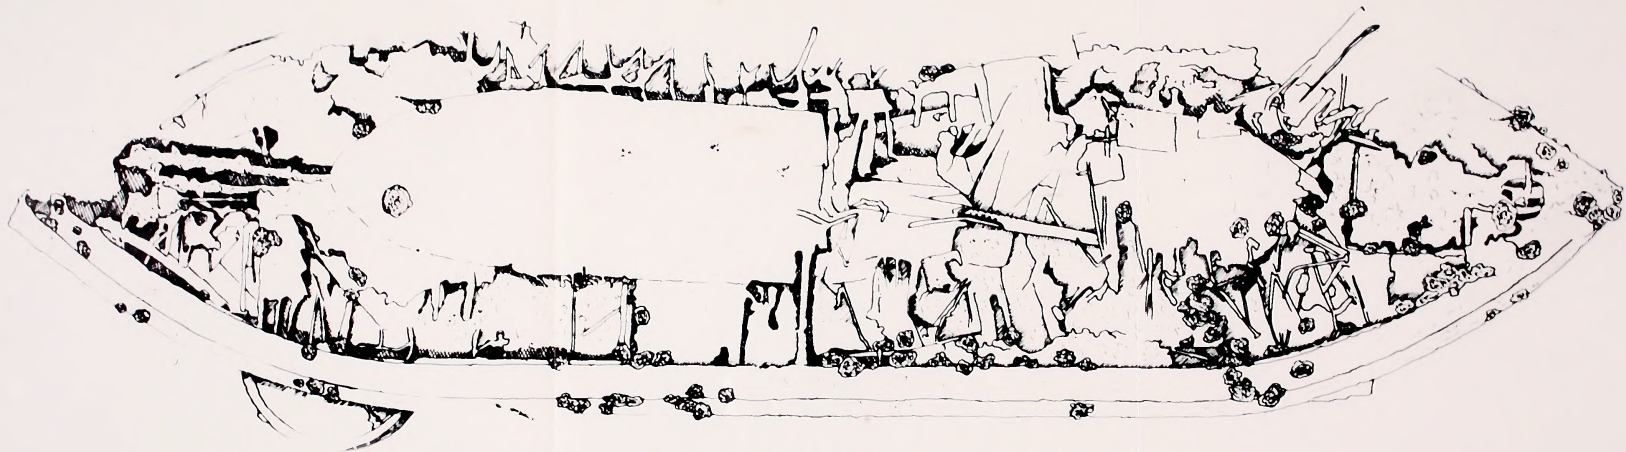
The hull of the *Monitor* lies in an inverted position with the port quarter armor belt resting on the displaced turret (*Figure 17*). The position of the turret and scour settling along the starboard armor belt have combined to elevate the stern and produce an exaggerated list to starboard. The longitudinal axis of the hull lies on a bearing of 290 degrees with the bow to the west-northwest.

Figure 17. Rendering of the wreckage of the U.S.S. Monitor.

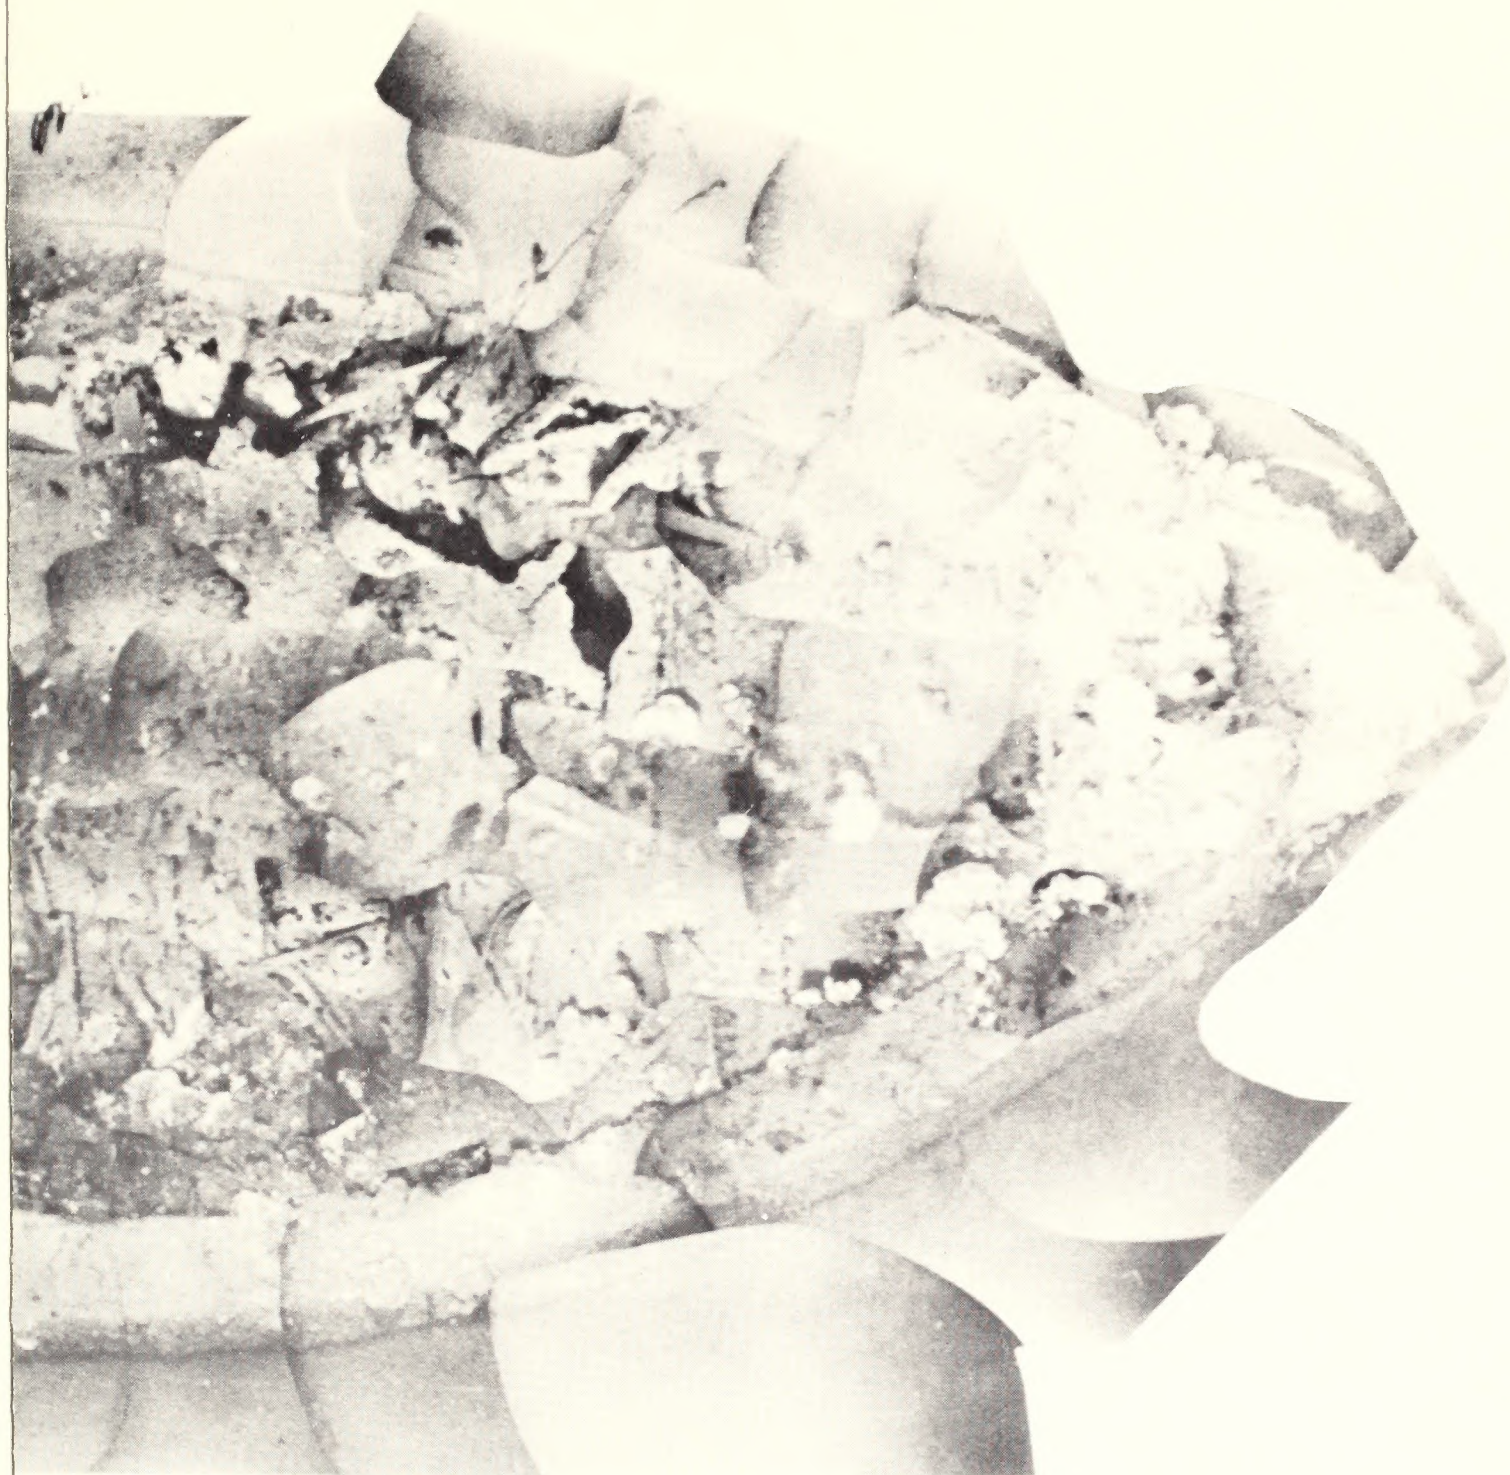
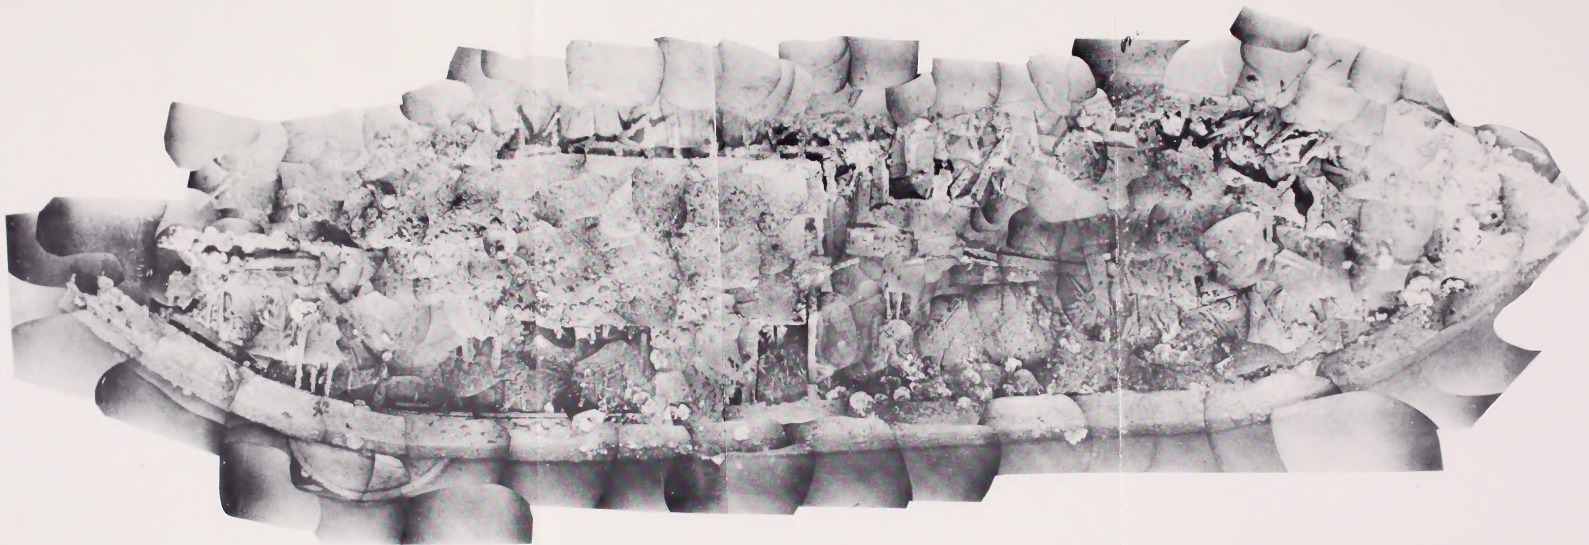
Detailed examination of the wreck confirms that the condition of the lower or displacement hull aft of the amidships bulkhead differs dramatically from forward portions of the hull (*Figure 18*). Bottom plating on the lower hull aft of the amidships bulkhead survives intact where supported by boilers, machinery, and machinery foundations in the engineering spaces. Along both sides of the aft lower hull plating has deteriorated and only the supporting frames remain. In the extreme stern the armor belt has been extensively damaged along with portions of the overhanging deck (*Figure 19*). Damage to the deck extends from the stern as far forward as the present location of the turret and an extensive amount of armor plate has been dislodged. The rudder skeg and propeller support yoke located aft of the displacement hull have been displaced because of extensive damage to the stern but remain near their original positions supported by the propeller shaft and propeller (*Figure 20*). Inside the hull the steam propulsion plant, boilers, blowers, pumps, and associated machinery remain relatively intact.

Figure 18. Mosaic assembled from Alcoa Seaprobe photographs by the Naval Intelligence Support Center.

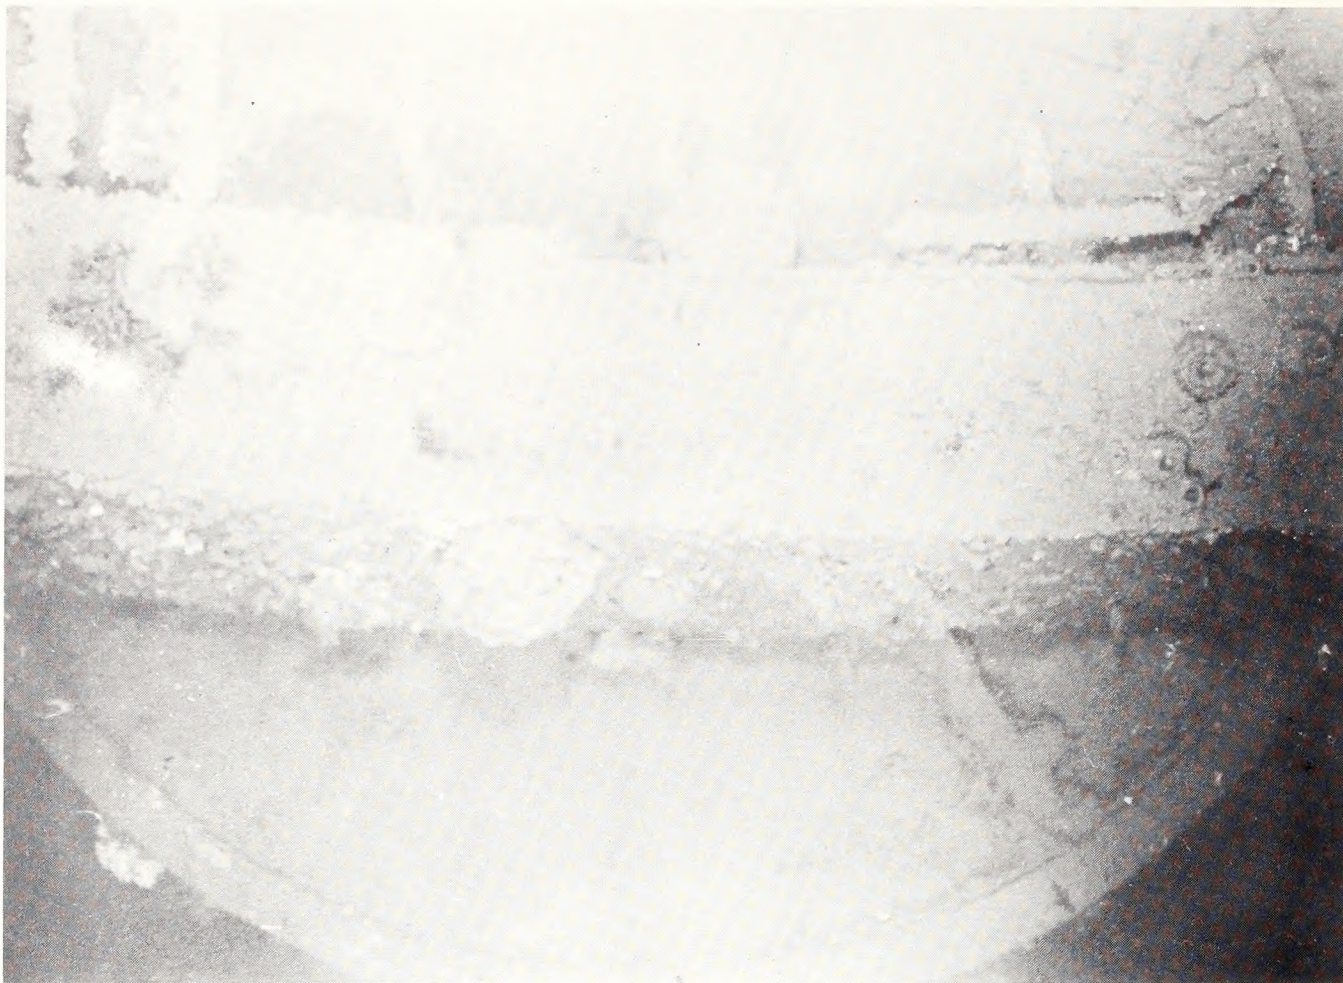
Exposed portions of the turret appear structurally sound and exhibit little evidence of deterioration. The gun ports, visible beneath the hull, remain closed by pendulums secured to the interior wall (*Figure 24*). While the wood floor of the turret has been extensively damaged by toredo and cellular deterioration, it remains structurally intact.

Figure 24. The turret, dislodged in sinking, lies partially exposed below the port quarter armor belt.

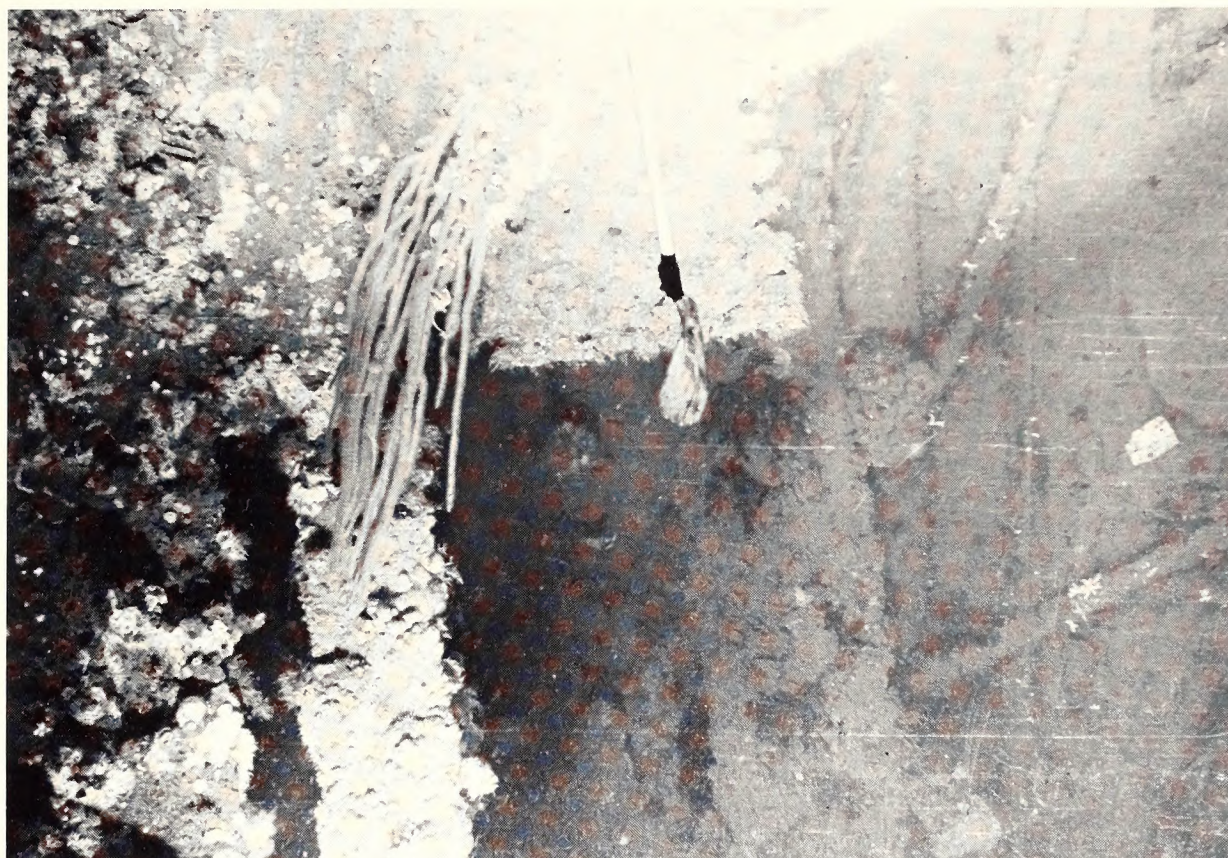
Figure 35. The hard chine separating the flat bottom and sides of the *Monitor*'s lower displacement hull.

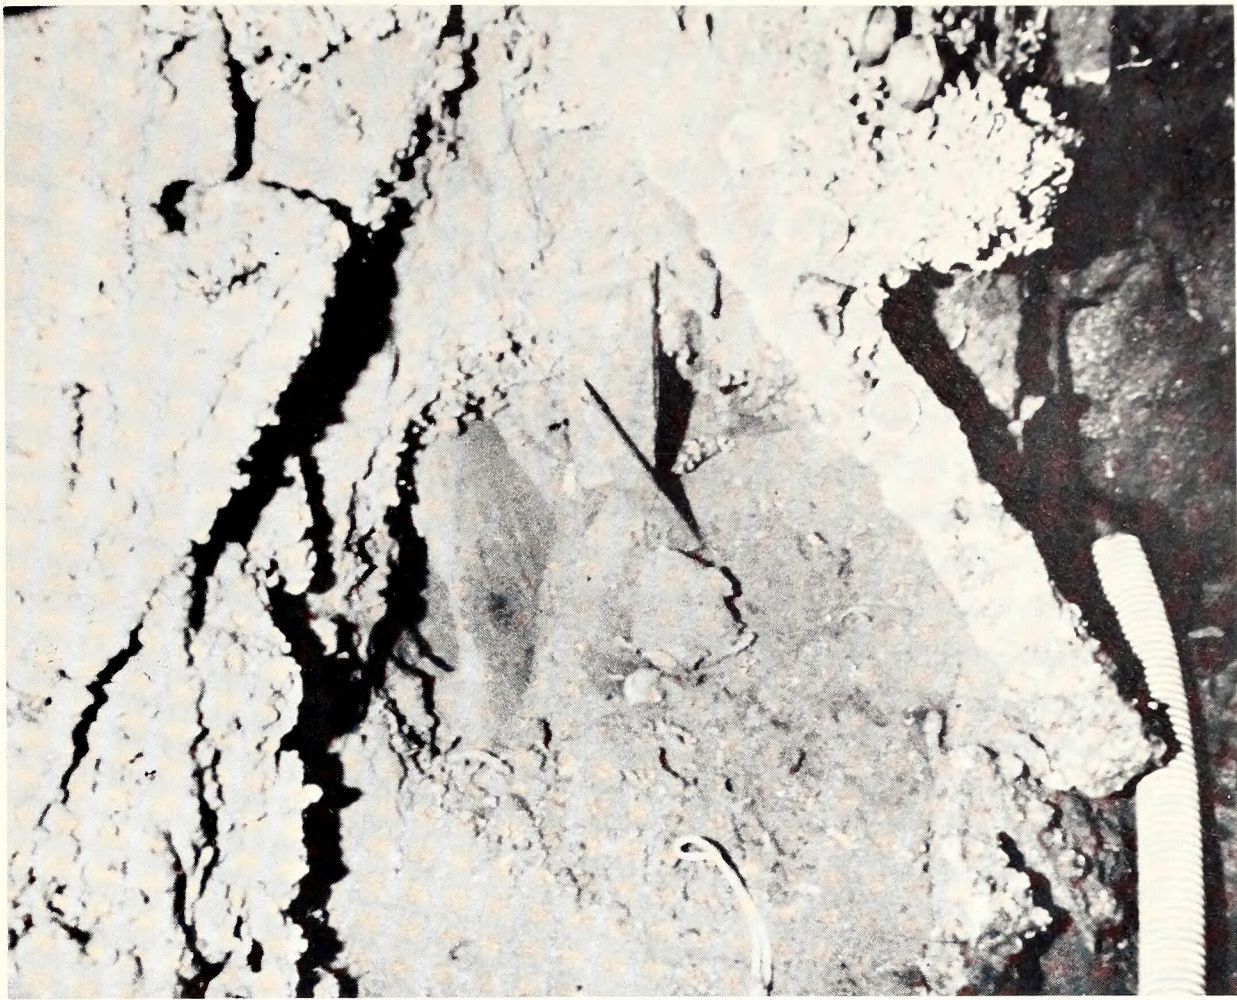
Figure 65. Fragments of wood paneling (left center) and deck beams (right center above dredge intake) exposed in situ in level 4 of the test excavation.

subsurface structural features dictated that excavation of the lower levels be carried out in a restricted area (Figure 65). Heavily concreted structural iron located along the north and east extremities of the test area precluded all but the most superficial investigation. As additional immovable material was uncovered, the scope of the excavation was reduced and reoriented toward the south and southwest. Only in the southwest corner of the test area was it possible to expose the underside of deck timber.

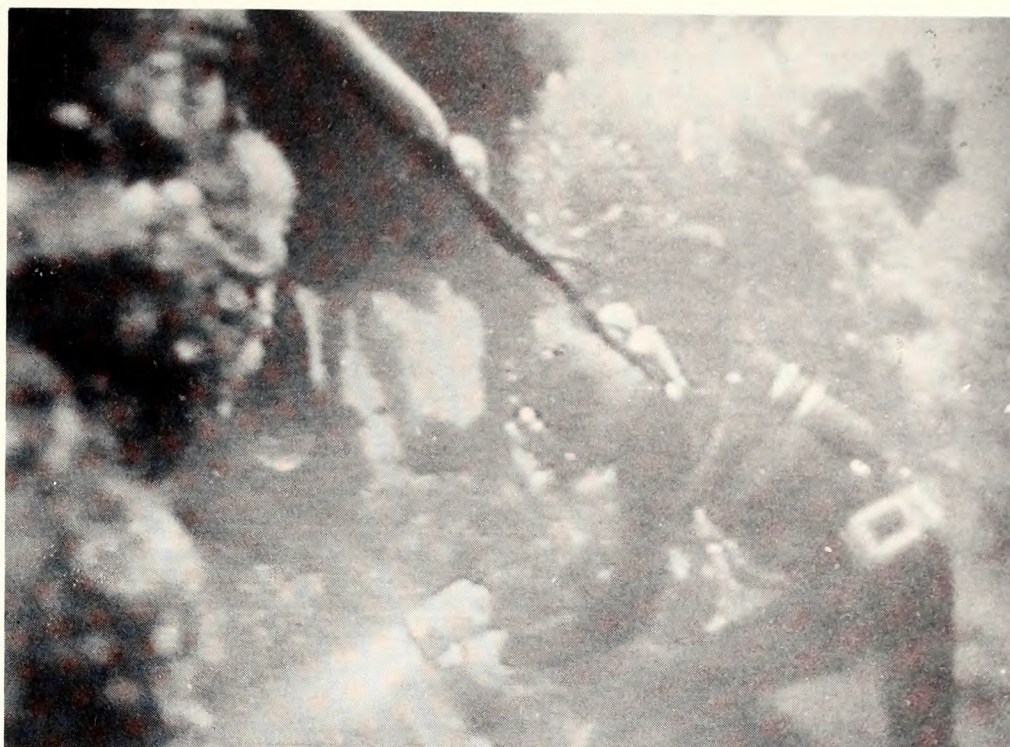
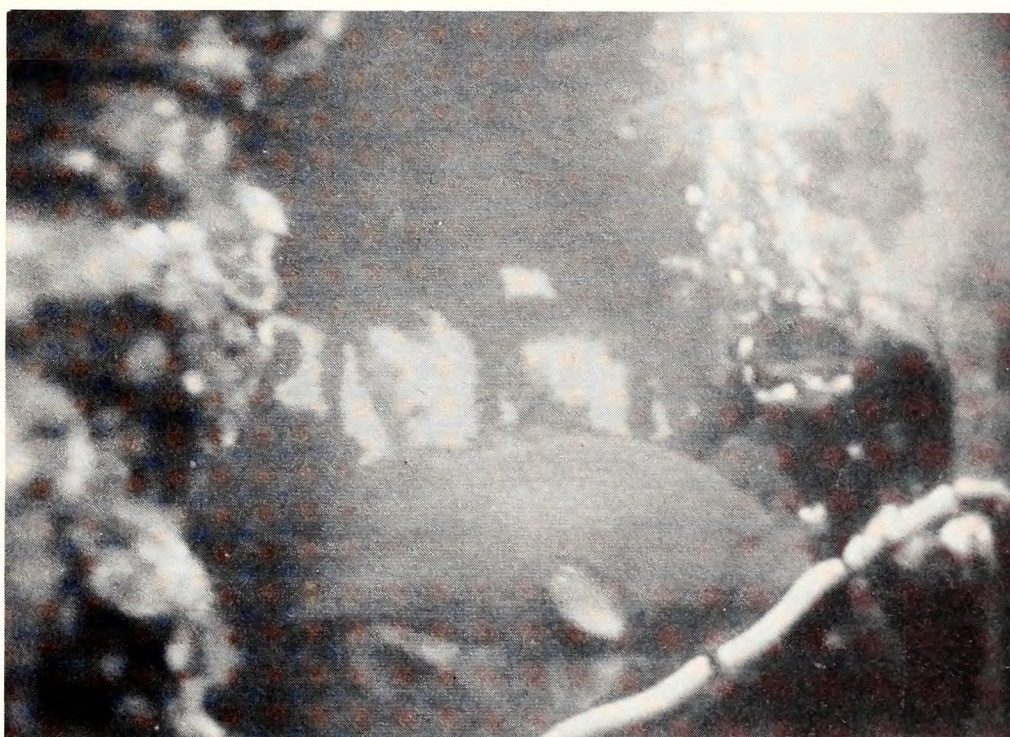
Figure 68. Exploration of the interior of the Monitor aft of the amidships bulkhead generated numerous observations, many of which were documented on closed-circuit television tape and 35 mm. film.

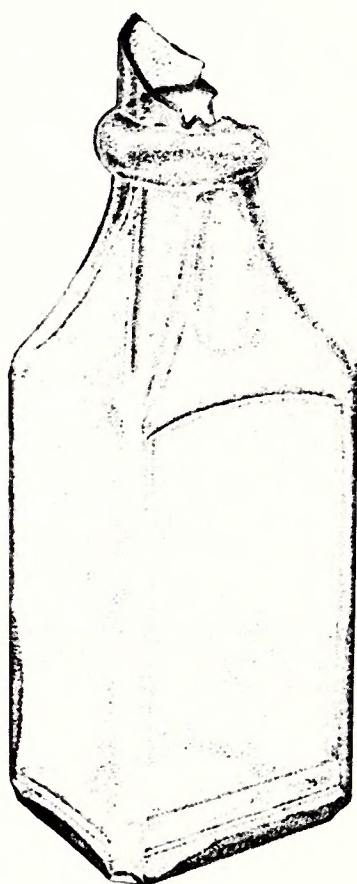
MONITOR 039

This is a portion of a light green three-piece molded rectangular food storage bottle. Base measurements are 3 inches by 2 5/16 inches, although each side is slightly concave. A 1 1/2-inch diameter circular depression extends 7/16 inches into the base of the bottle and contains three embossed beads spaced 5/16 inch apart along the short axis of the base. Each corner of the base is eliminated by a mold design clipping the apex and producing a triangular face 1/4 inch in height. The face of the bottle body contains a rectangular recess approximately 1/16-inch deep and arched at the top to permit application of a label. At a height of 5 1/4 inches above the base, the body of the bottle forms a shoulder and converges to form the base of a 1 3/4-inch neck base. Both the front and rear of the bottle contain a teardrop design immediately below the neck and the sides are molded to form an inverted "V." A collar 1 3/4 inches in maximum diameter and 3/4 inch wide serves as the base for a 1 9/16-inch diameter tubular neck.

Broken. Top and portions of the neck are missing.

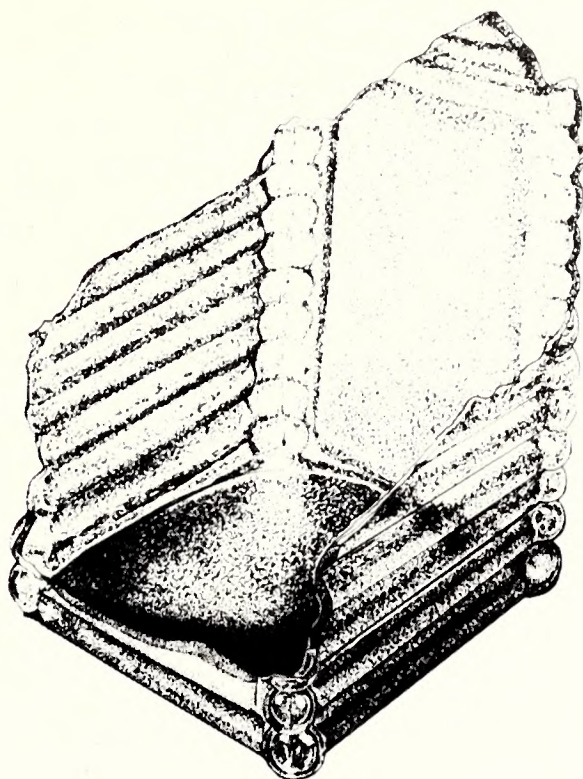
MONITOR 041

The amber bottle base fragment measures 3 inches square. The slightly concave base of the fragment contains a 3/16-inch deep circular depression 2 1/8 inches in diameter. The sides of the body are formed to simulate log cabin construction features with 3/8-inch diameter logs forming joints at the corner of the bottle. Above the first "log," two sides of the body are recessed and molded flat to form a rectangle 3 7/16 inches in height and 1 3/4 inches in width. Above this the molded logs continue to form the sides.

Broken base fragment

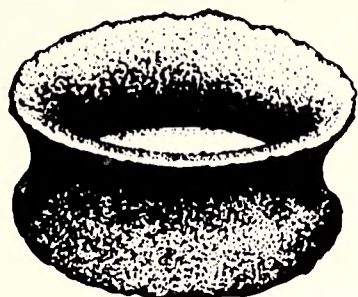
Monitor: 011

Description: The brass thimble is 1 11/16 inches in maximum diameter with a 1 1/8-inch interior diameter.

Condition: Good

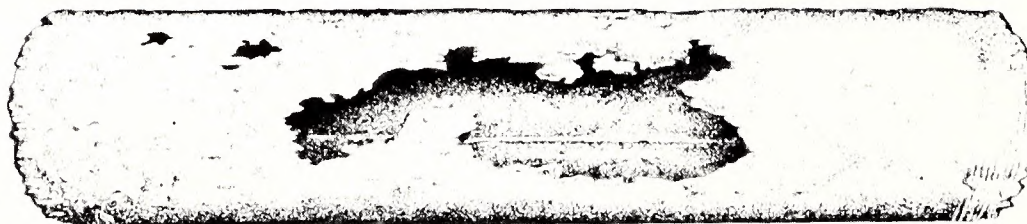
MONITOR 110

Figure 81
Artifact: Iron pipe
Monitor: 110
Description: The section of wrought iron pipe is 6 5/8 inches in outside diameter and 48 inches long. From a single piece of 1/4-inch plate, the section is rolled to form a longitudinal butted seam that was heat- and pressure-welded. One end of the section is threaded for a length of 2 inches with eight threads formed per inch.

Provenance: Surface sediment under the port quarter aft of the turret; area G (*Figure 109*).
Association: Lower hull engineering space
Condition: Good

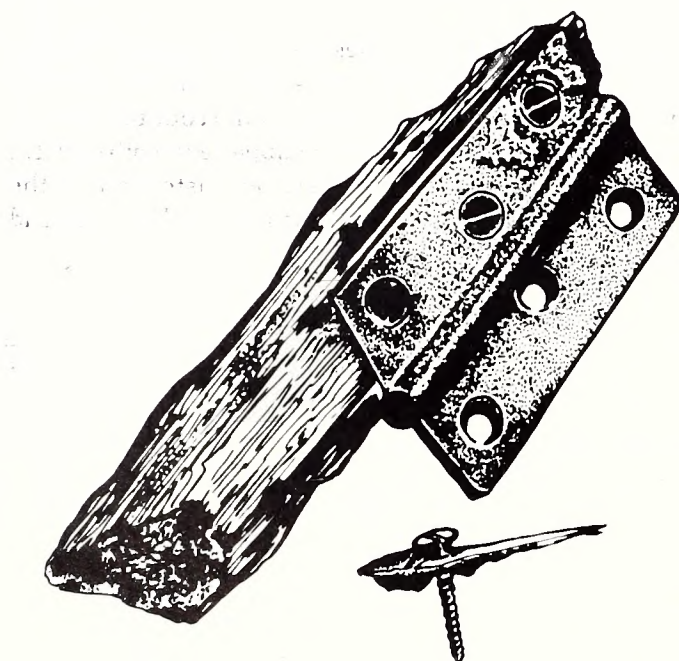
MONITOR 005

The larger fragment of pine measures 5 inches by 1 5/8 inches in width and is dressed 7/8 inch thick. The surviving finished edge has been inletted for and contains a 2 1/2-inch long, 2 1/8-inch wide (extended) brass cabinet hinge. Three 1-inch long #12 screws attach the hinge to the wood fragment. A fourth 1-inch #12 flathead wood screw located in the opposite side of the hinge retains a small fragment of wood, also inletted to accept the hinge. The finished surface of the larger wood fragment additionally contains two nail holes driven perpendicular to and between the screws retaining the hinge. Concretion patterns on the face of the fragment indicate that the nails attached a 2-inch wide piece of wood perpendicularly to the first piece.

Provenance: Test excavation level 4; area A (Figure 109).
 Association: Joinery from officers' quarters
 Condition: Hinge, good; wood, fair.

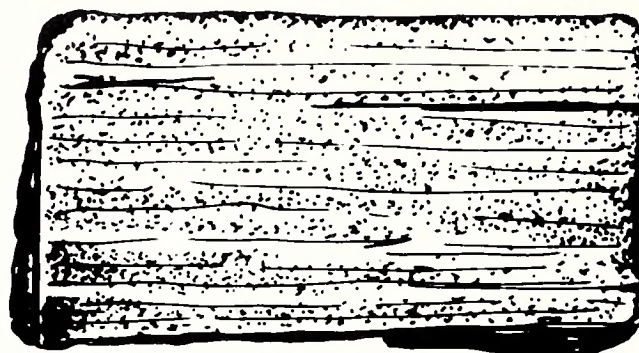
MONITOR 056

Figure 90
 Artifact: Wood fragment
 Monitor: 056
 Description: The pine fragment is 3 1/4 inches long, 1 5/8 inches wide, and 3/8 inch thick.

Provenance: Test excavation level 4; area A (Figure 109).
 Association: Joinery from officers' quarters
 Condition: Excellent

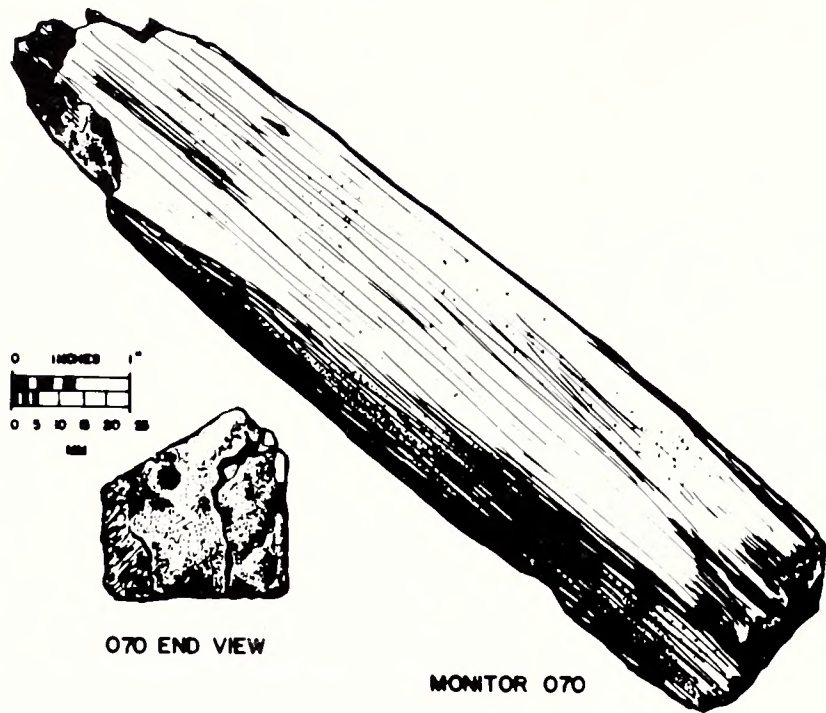
Figure	95
Artifact:	Wood fragment
Monitor:	070
Description:	The fragment of pine corner molding is 8 1/2 inches long, 1 5/8 inches maximum thickness, and 1 1/2 inches maximum width.

Provenance:	Test excavation level 4; area A (Figure 109).
Association:	Joinery from officers' quarters
Condition:	Good

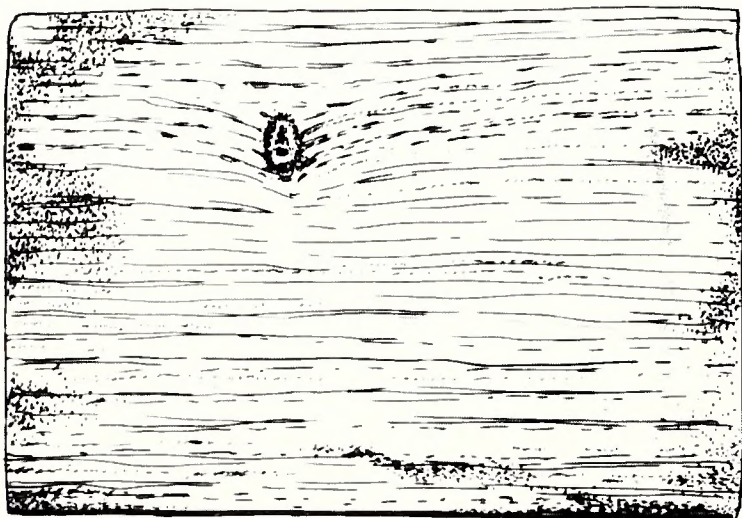
Figure	96
Artifact:	Wood fragment
Monitor:	071
Description:	The sandalwood fragment measures 4 7/8 inches in length, 3 5/16 inches in width, and 1/4 inch in thickness. Saw marks on one of the finished sides have been almost removed by sanding or dressing and both ends and one finished edge contain small tack or wire nail holes.

Provenance:	Test excavation level 4; area A (Figure 109).
Association:	Officer's effects
Condition:	Excellent

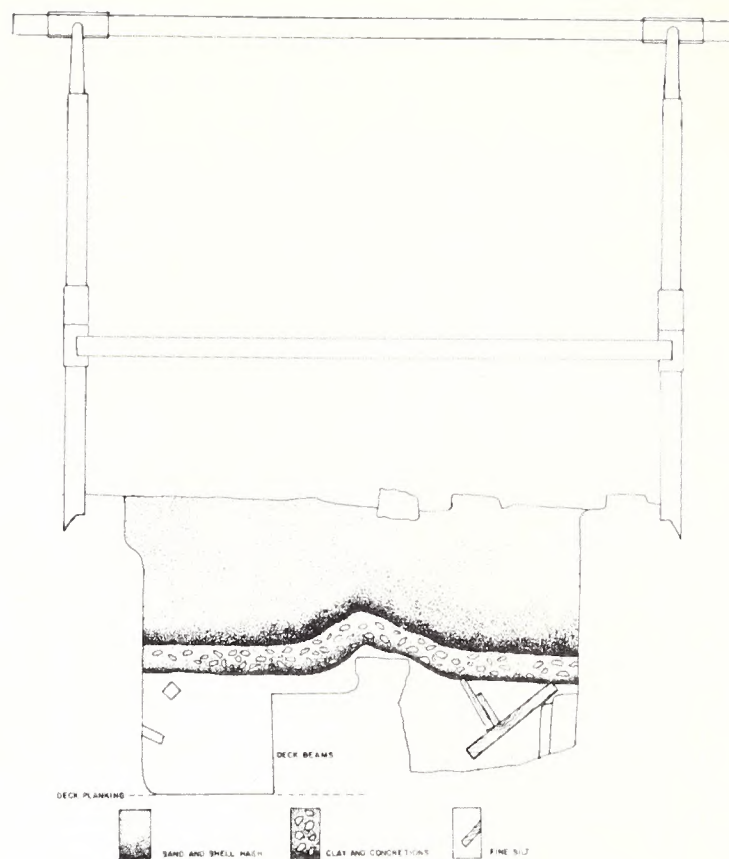
Figure 111. South profile of test excavation.

The sand and shell hash compositions of this upper stratum of sediment differed distinctly from the stratum of mixed sand and clay found 14 inches to 16 inches below the sediment surface. Varying in thickness from 3 inches to 5 inches, this stratum was clearly distinguishable from the sand and shell hash above it. While neither modern debris nor artifacts associated with the *Monitor* were found at this level, numerous small concreted fragments of lower hull structure were present. It is possible that this stratum is associated with the destruction of the *Monitor's* lower hull. Concreted material indicated that the ship had accumulated an extensive calcarious crust before the hull collapsed.

Below this second stratum sediment was found to consist of a fine silt and occasional clam shells. Although lower hull plate and frame fragments associated with features of the lower hull were present in this layer, none of the small separate concretions was found. Perhaps this layer accumulated as waterborne organic material and light sediment filled the hull prior to collapse (Figure 111).

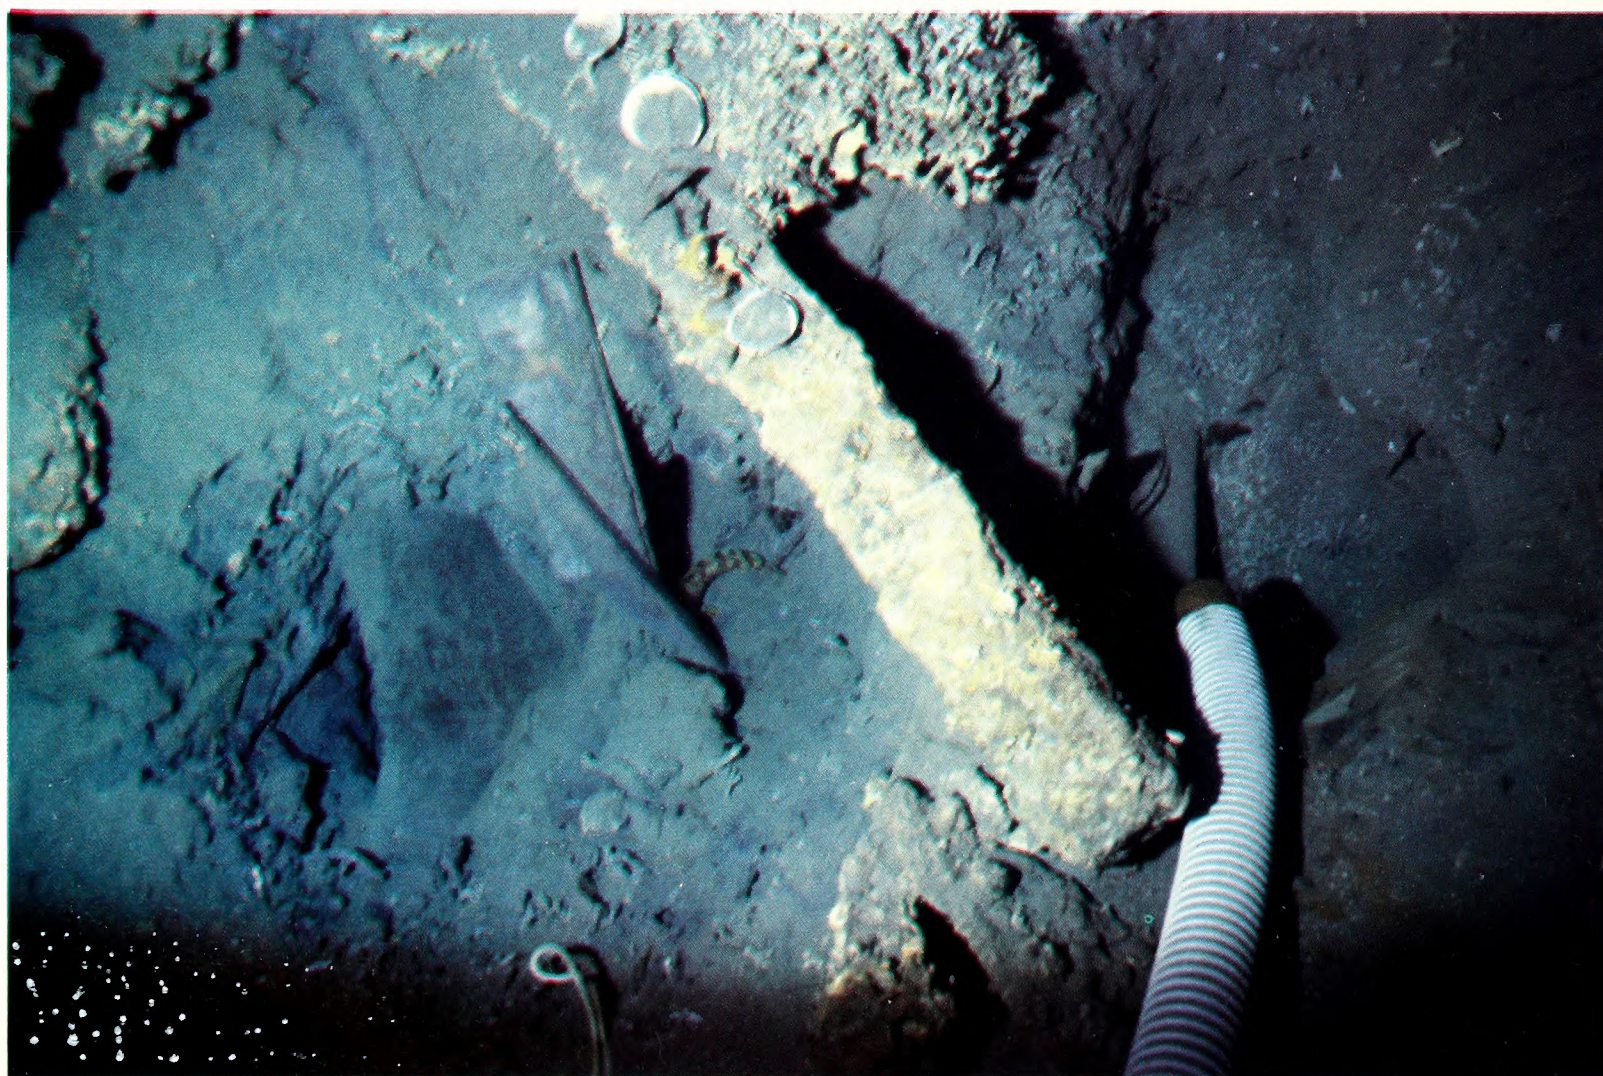
Figure 112. Although restricted by structural material from the collapsed lower hull of the Monitor, excavation at the test site was carried to a depth of 4 feet and exposed portions of the vessel's deck beams and planking. On the left of an iron frame dividing the south half of the test pit, the remains of a tongue-and-groove pine bulkhead were identified and recovered. To the right of the diagonal frame and directly underneath the nozzle of a 2 1/2 inch induction dredge used to remove sediment from the test, one of the ship's deck beams can be seen. Lying on the beam beneath the shadow of a wood fragment are the well-preserved remains of a leather-brimmed, rubber-impregnated canvas sou'wester hat. Because the foul weather gear was secured to an iron bolt in the deck by corrosion, the decision was made to leave it *in situ*.

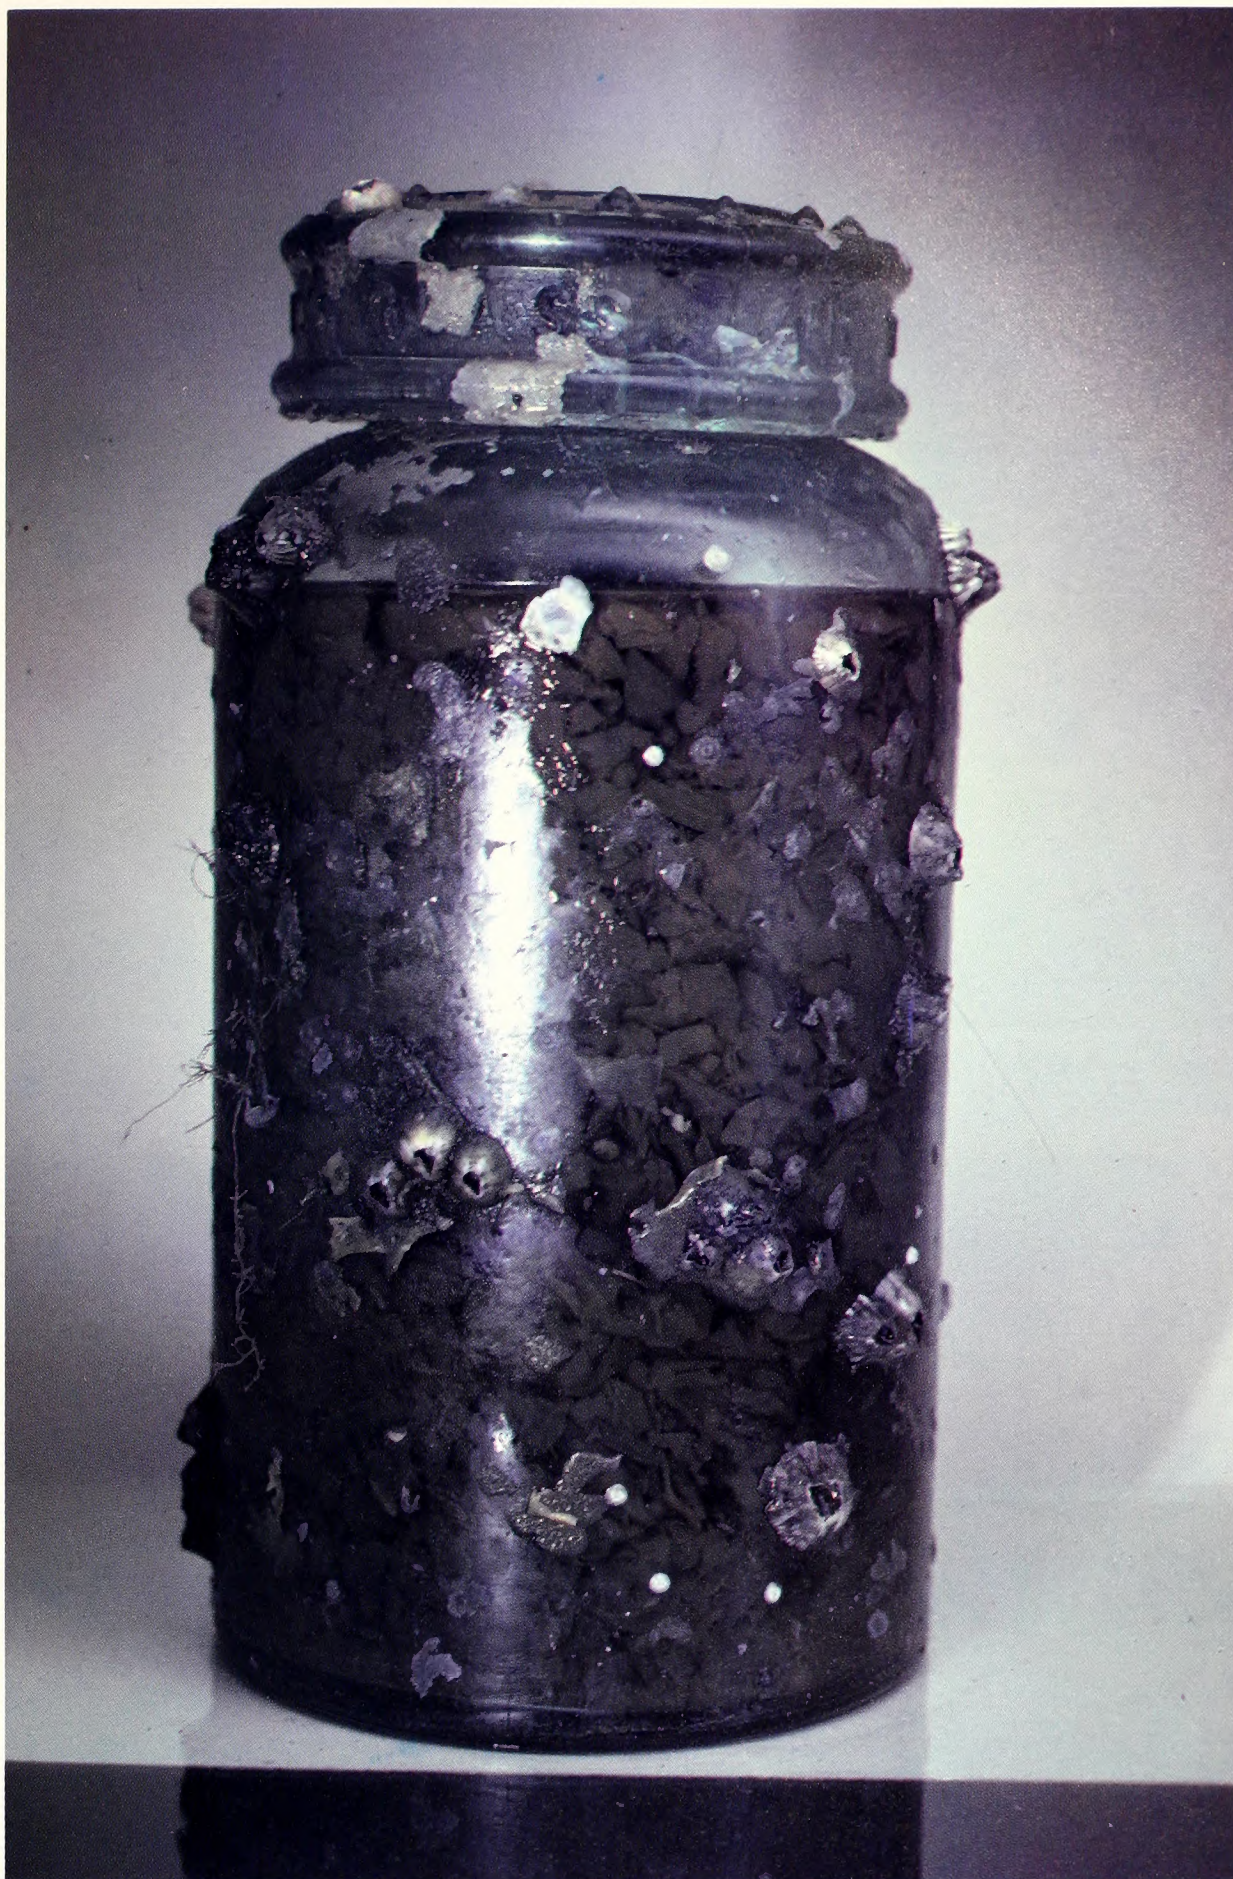
Figure 115. A Hartell's Glass jar containing relish, the lid and seal intact, was recovered from the north side of the wreck in the vicinity of the wardroom.

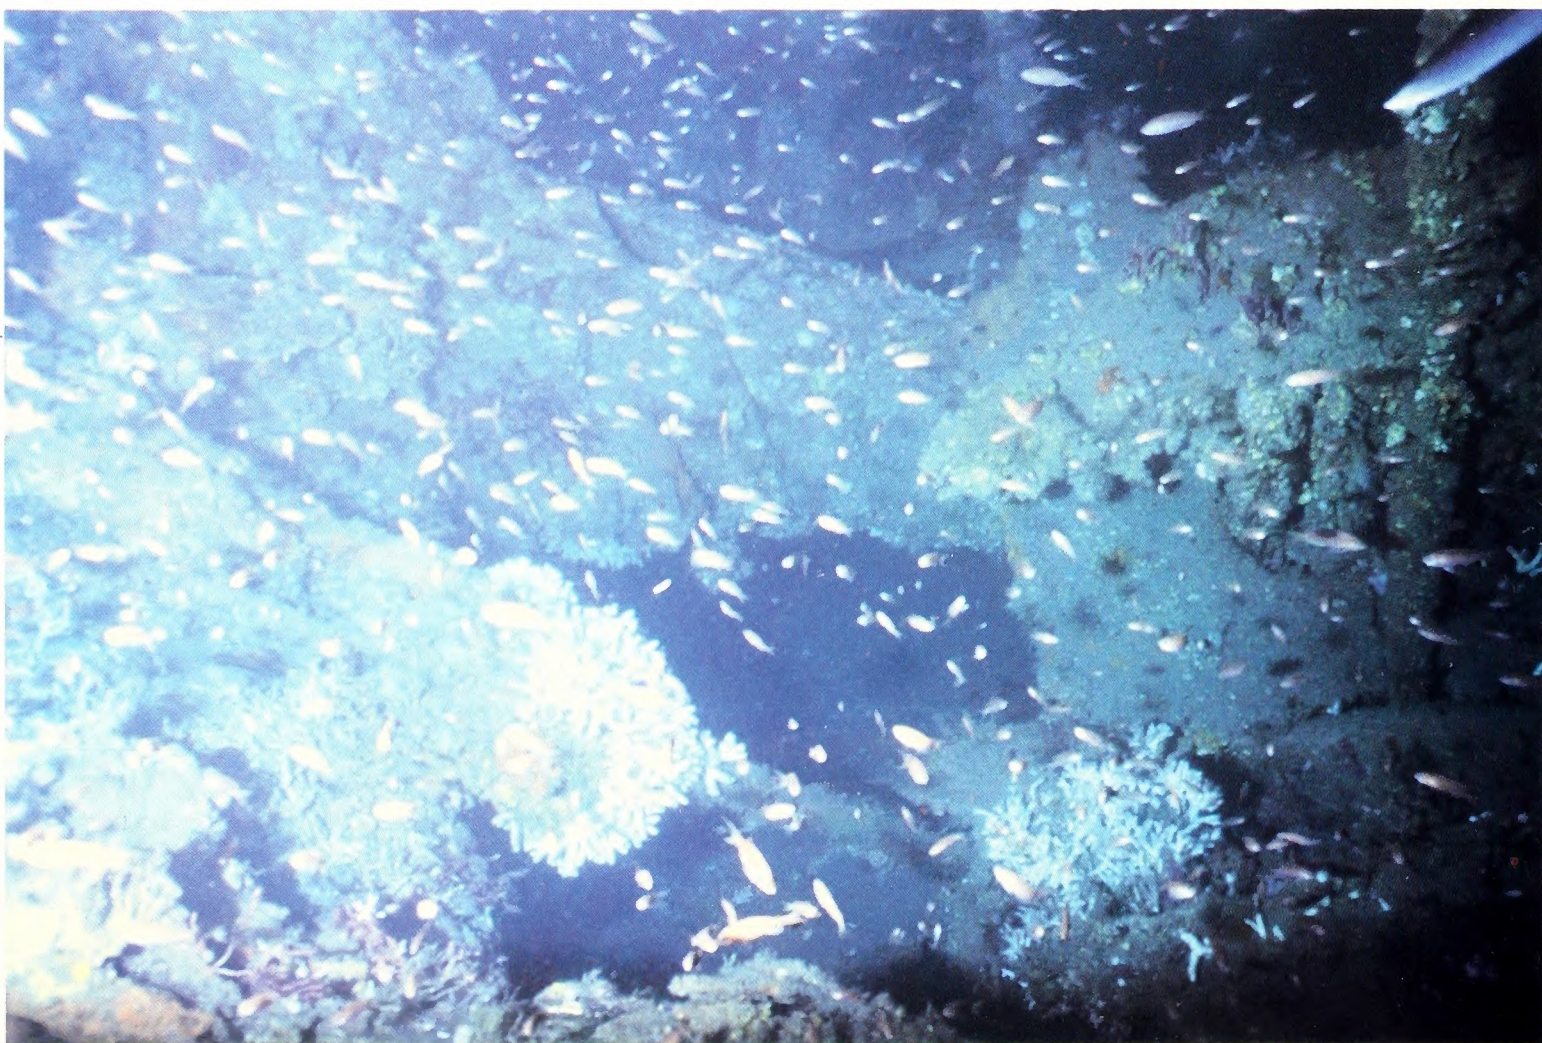
Immediately forward of the amidships bulkhead and inboard of the port armor belt, a second and larger rupture in the deck was identified (*Figure 116*). There damage was observed to have affected approximately 70 square feet of the deck structure. Again exposed deck beams and planking evidenced extensive teredo and pholad damage. Material from deteriorated storage cabinets adjacent to the armor belt, portions of the amidships bulkhead plating, remains of cabinetry, and a copper bucket were observed, and numerous unidentifiable concretions were observed in the damaged area and on the sand immediately below. Adjacent to the damaged area, armor plates on the deck were found to have separated from the wood deck structure.

Figure 116. Immediately inboard of the port armor belt and forward of the amidships bulkhead, damage to the armored "raft" has left a substantial hole in the deck structure.
